Robson Lapina

Forensic Engineers, Architects, Scientists & Fire Investigators

GABRIEL G. ALEXANDER, P.E.
Mechanical Engineer

Post incident inspection of the vehicle revealed that the lower safety cable above the cab on the driver's side had failed.

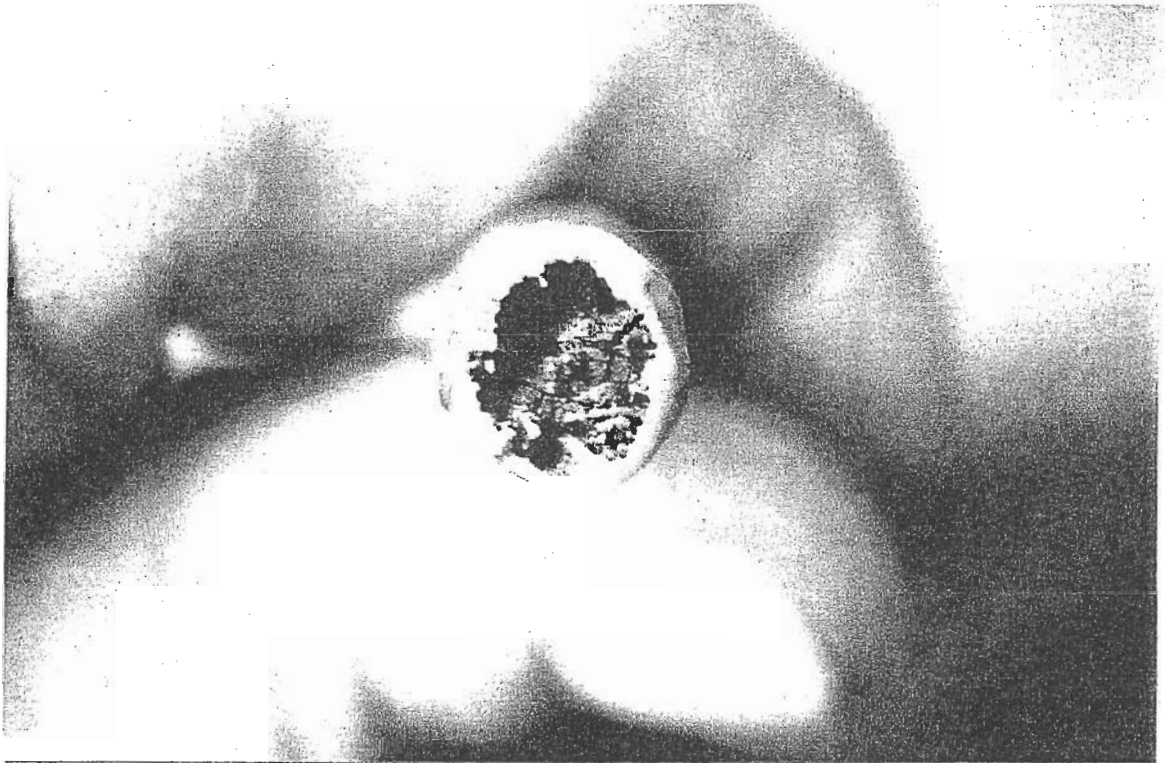
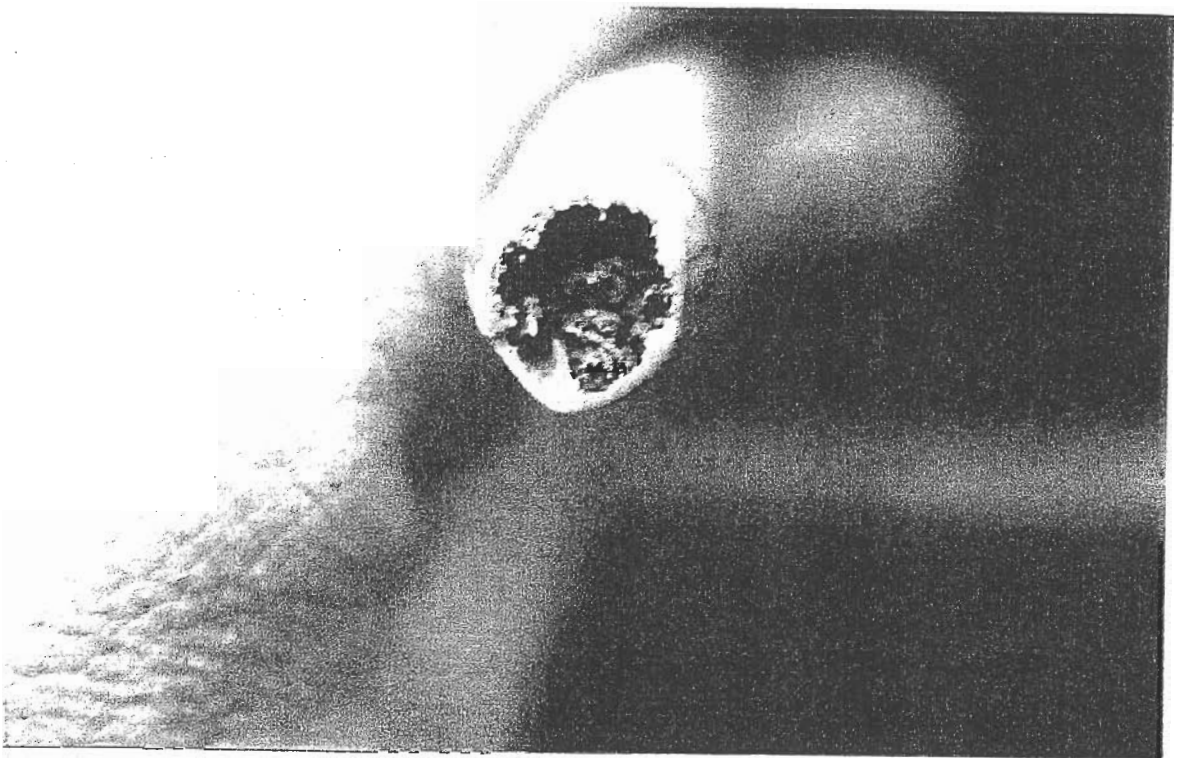
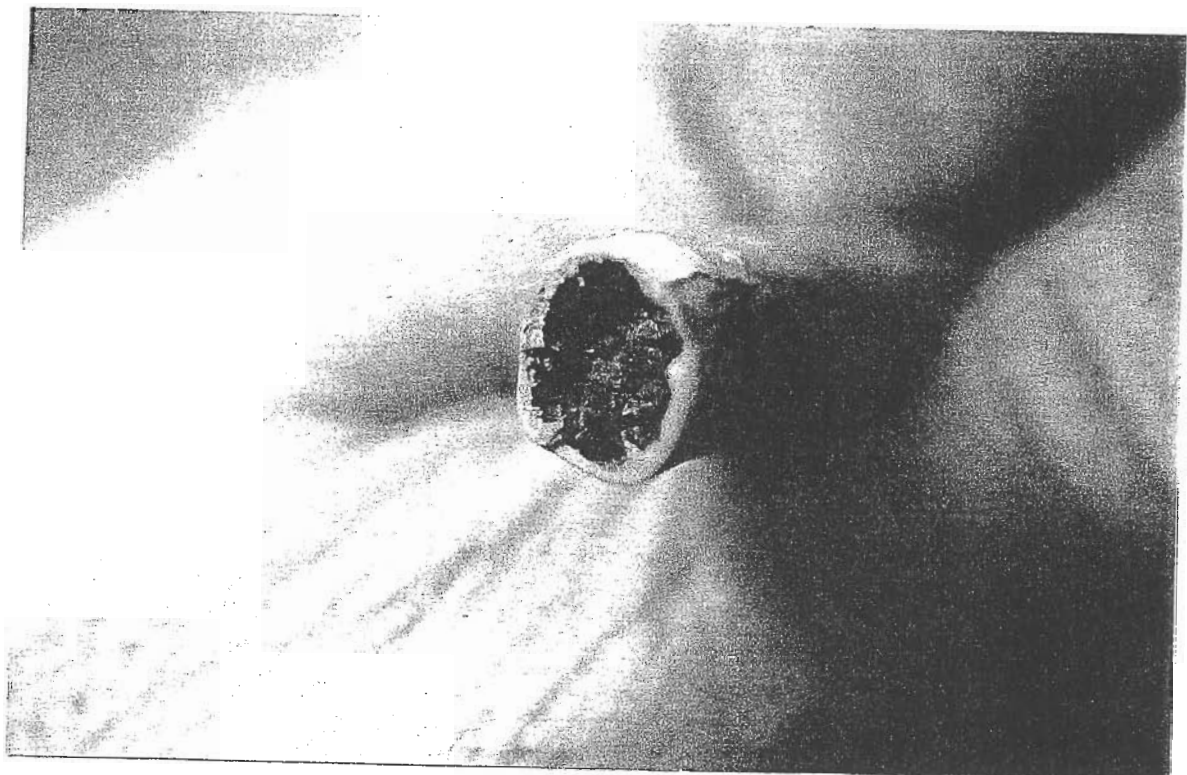
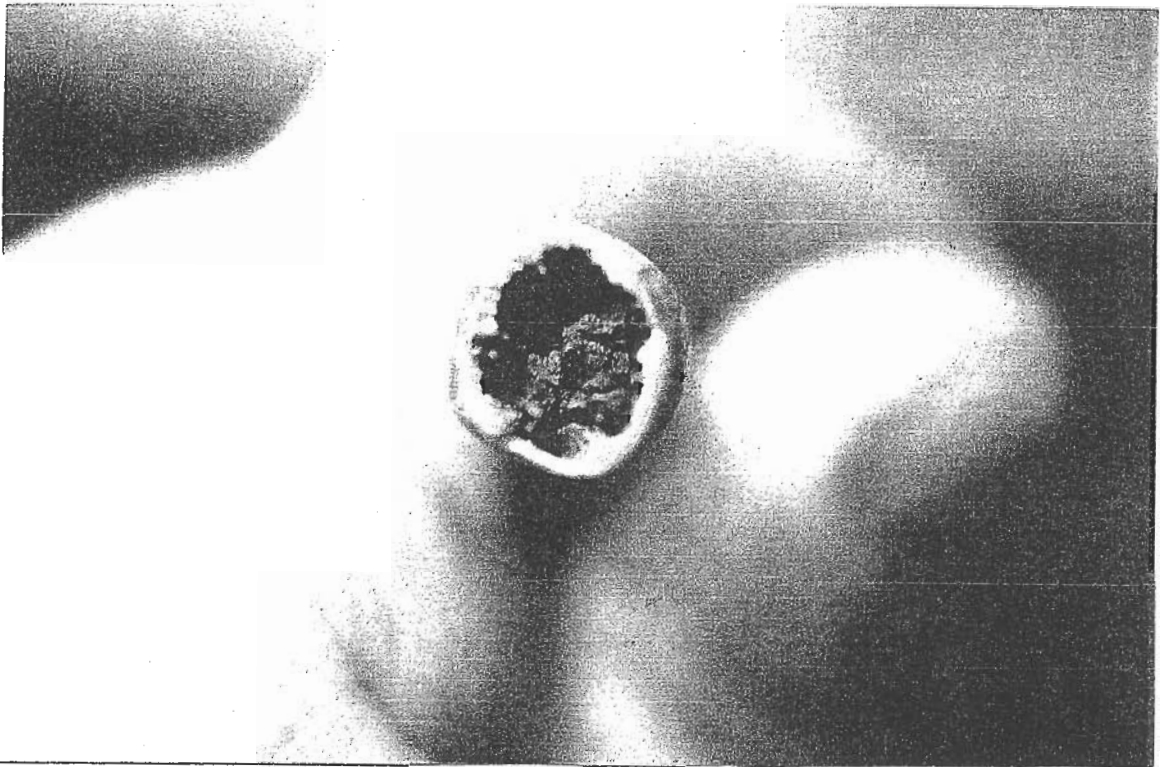
Photographs 34 through 38 are close-up views of the failed end of the cable as viewed looking edge on, down the cable axes. The photographs reveal that the cable is severely rusted. Further inspection of the cable revealed that the failure is consistent with a corrosion induced failure, which will be discussed later in this report. The presence of the swelling observed as noted above confirms this failure mode.

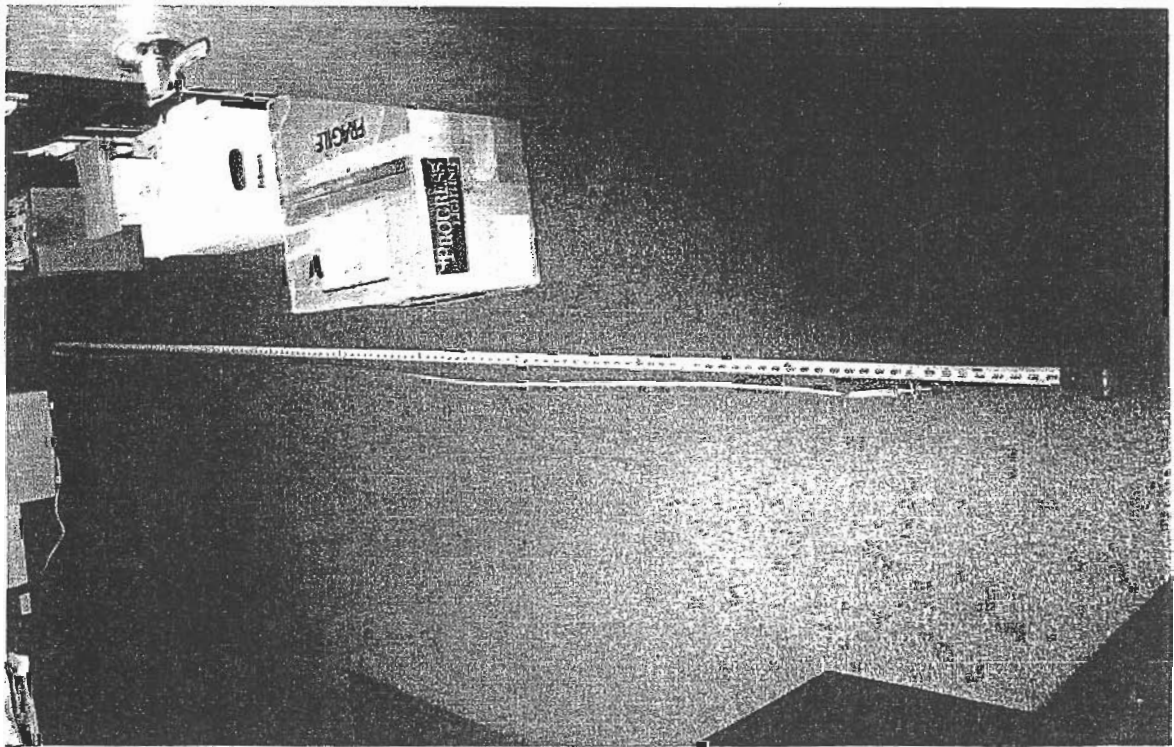
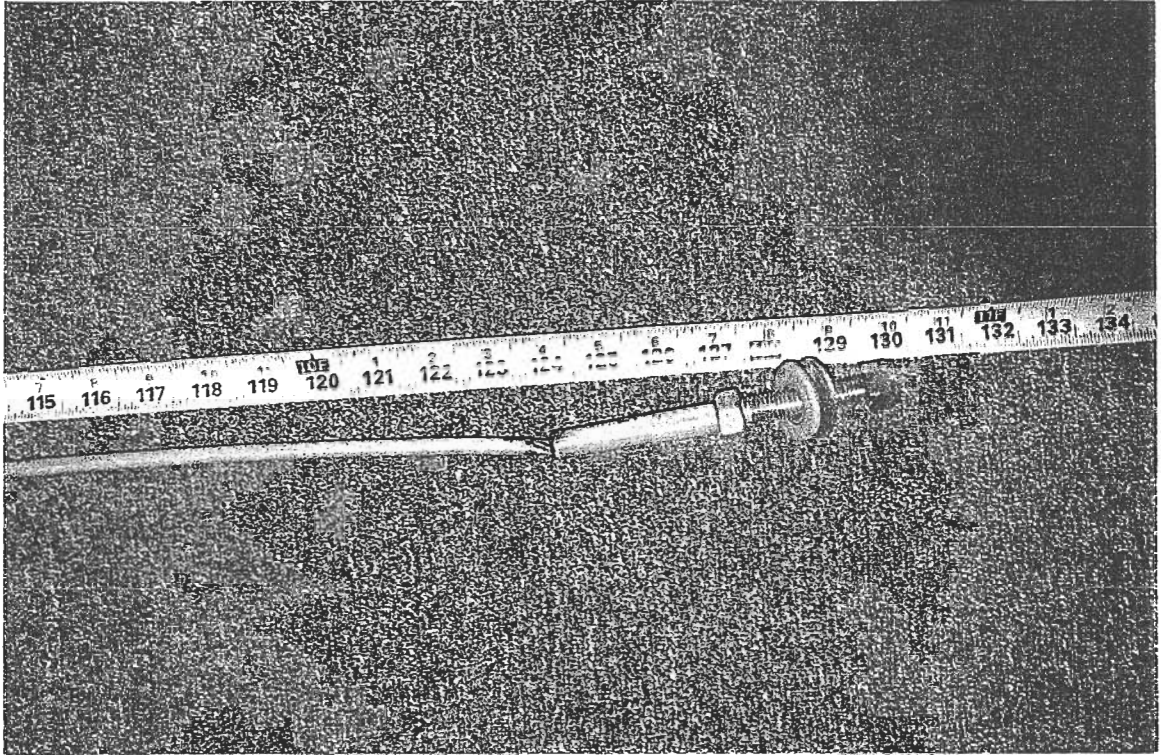
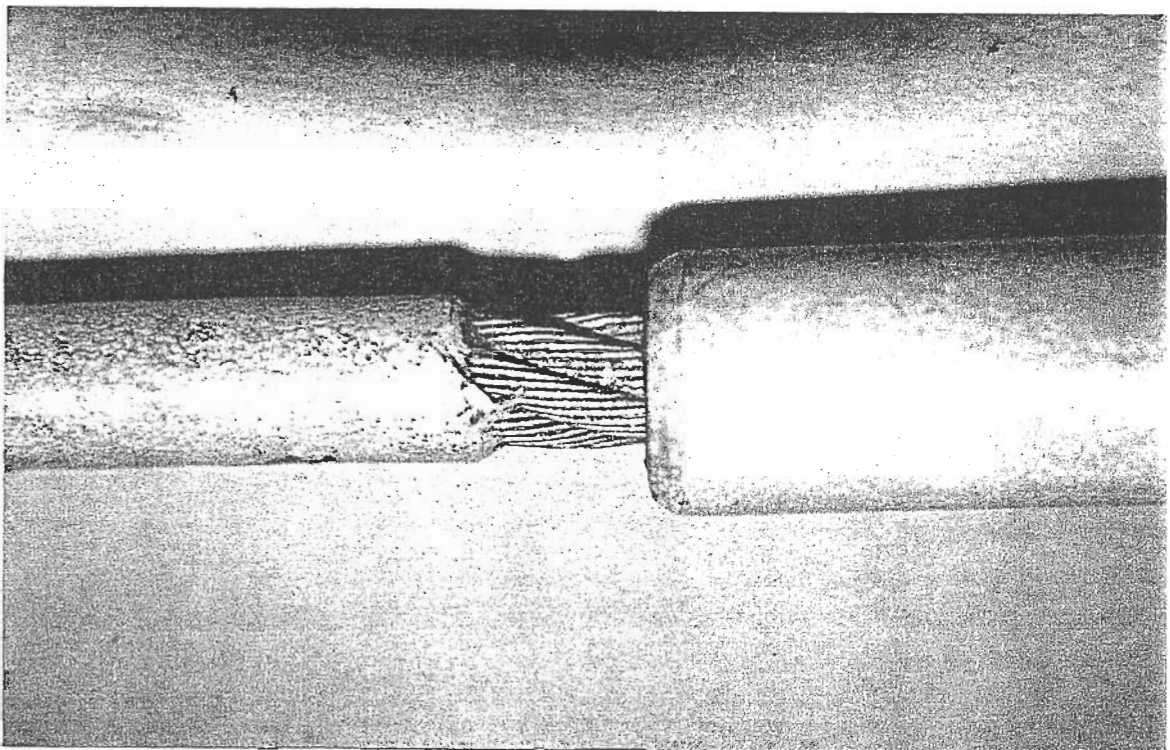
Photographs 39 through 44 are various views of the second exemplar I inspected. Photographs 41 through 43 reveal that the cable is not rusty. Further, a magnet was utilized to determine that both the cable and fitting material were stainless steel.

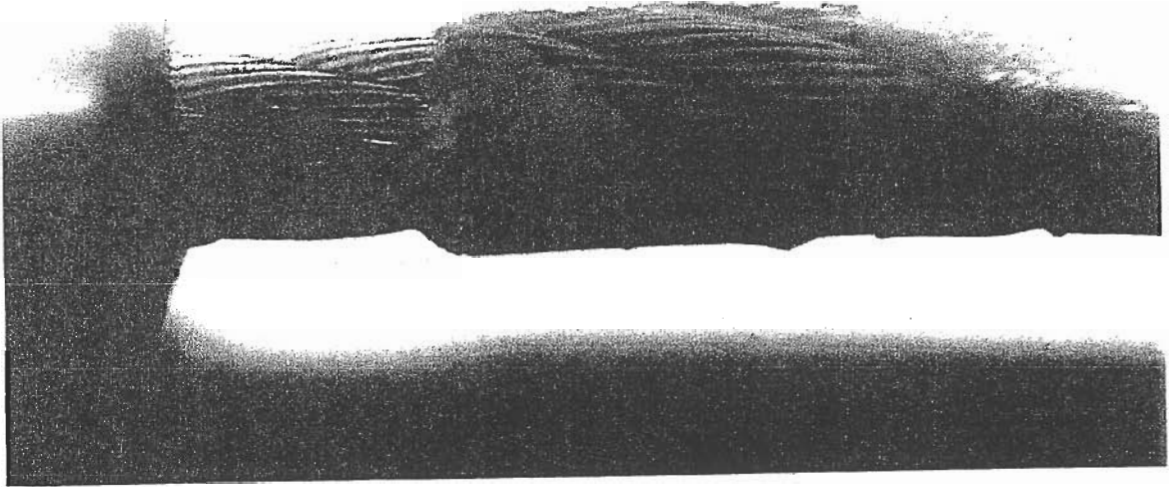
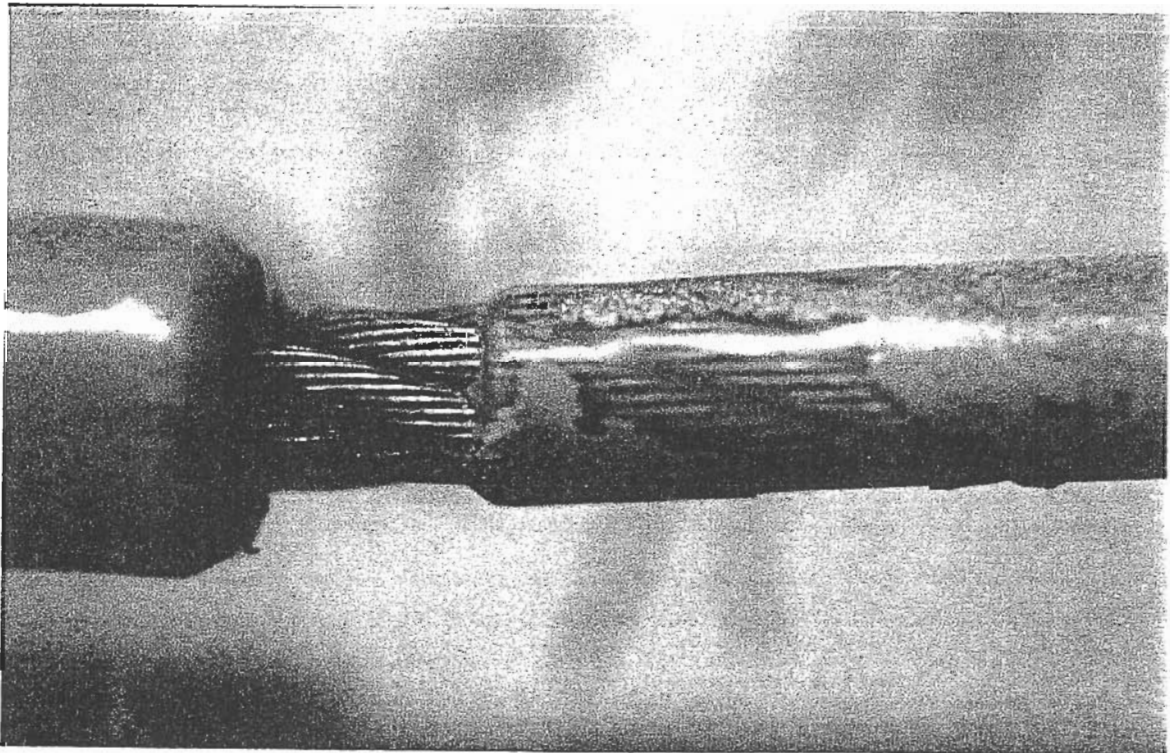
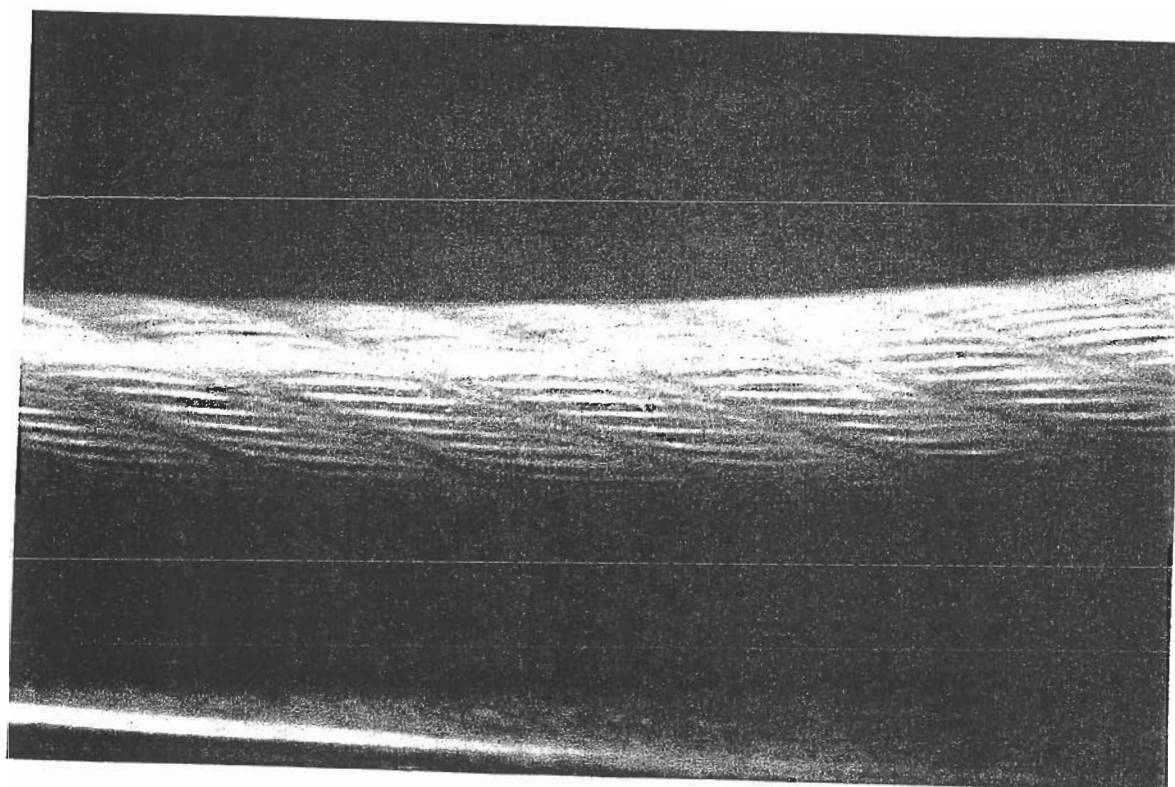
Examination of photographs 42 through 44 reveal that the cable coating is clear in color. Further examination reveals that the stainless steel cable can be readily viewed for inspection purposes through the clear coating.
